SR22® PISTOL PRODUCT SAFETY BULLETIN

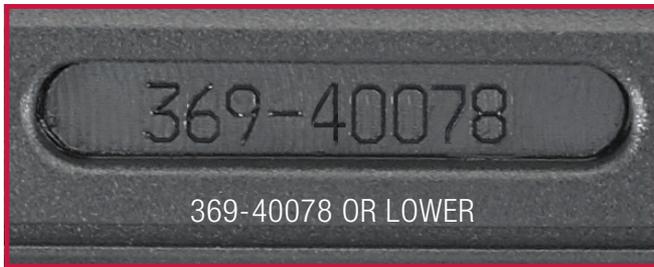
Any SR22 with serial number **369-40078** or lower (including those with a “SS” serial number prefix) is subject to this Safety Bulletin, **IF** it has either: (1) exhibited (or exhibits in the future) a slack single-action trigger; or (2) discharged upon decocking. If you have ever experienced either of these conditions with your SR22 pistol, you should stop using your pistol and **sign up** for the Safety Retrofit.

HOW TO SIGN UP FOR THE RETROFIT:

STEP 1: If you meet the criteria above, **sign up** for the retrofit at Ruger.com/SR22Retrofit or contact Ruger Customer Service at **336-949-5200**.
